BUILDING & PEST INSPECTIONS

9 Spotted Gum Lane, Cashmere

BPI - INSPECTION REPORT

9 Spotted Gum Lane, Cashmere.

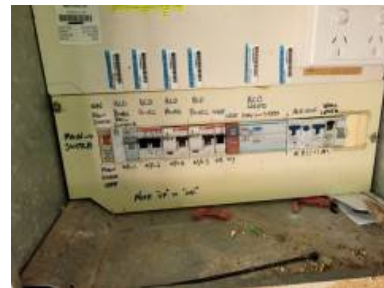
Whilst not an electrician, it appears that an electrical safety switch is present.

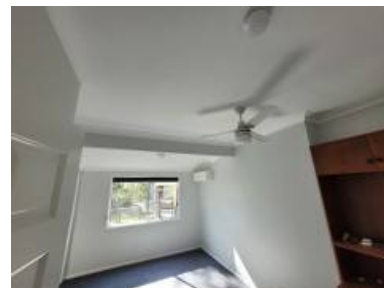
Present - Hall, All bedrooms

It is recommended that you request a copy of the compliance certificate. Confirming that all smoke detectors conform to the new Australian Standard AS 3786-2014.

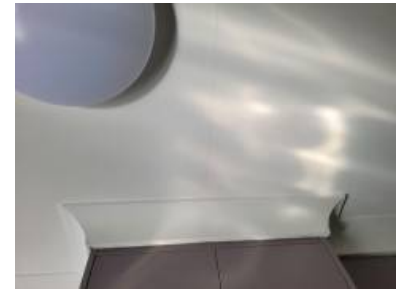
Hairline crack to ceiling sheet join in the Kitchen

Slight undulations to some ceiling sheet joins.

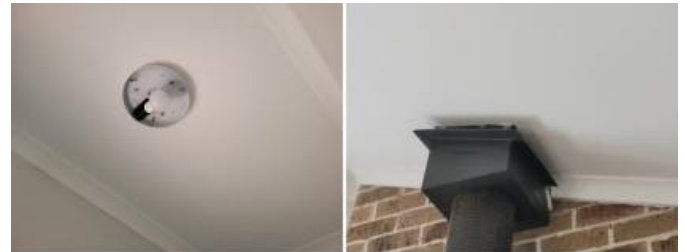
Some light covers are missing.

Fire place flue cover is loose & requires refixing flush to the ceiling.

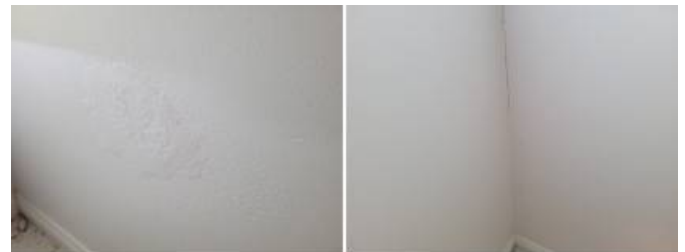
Some wall sheeting shows evidence of past patching.

Crack to wall sheet join to the Walk in cupboard.

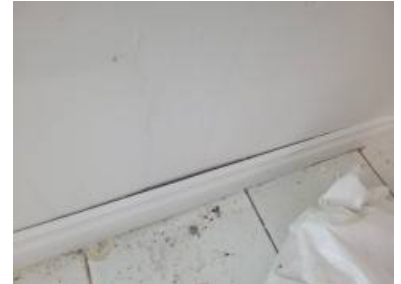
Gaps at some skirting wall joins require sealing.

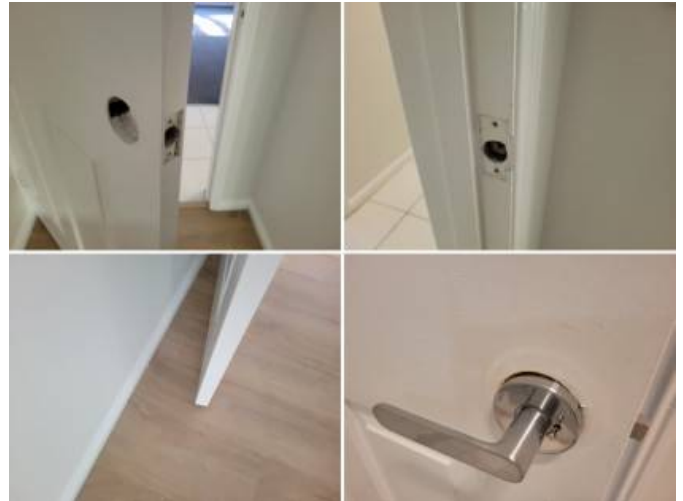
Some external slider rollers show signs of wear or are worn and require replacement.

Door handle requires refixing / adjustment.

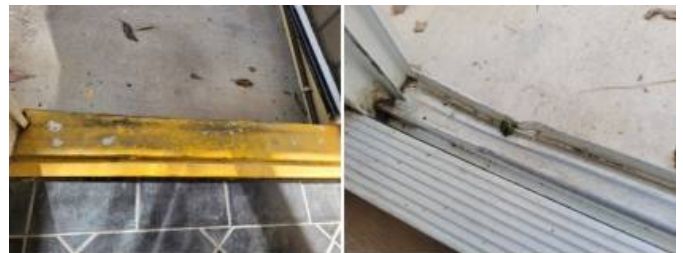
Paintwork to the Laundry door threshold requires touching up / repainting.

Minor damage to aluminum sliding door frame to the Bedroom.

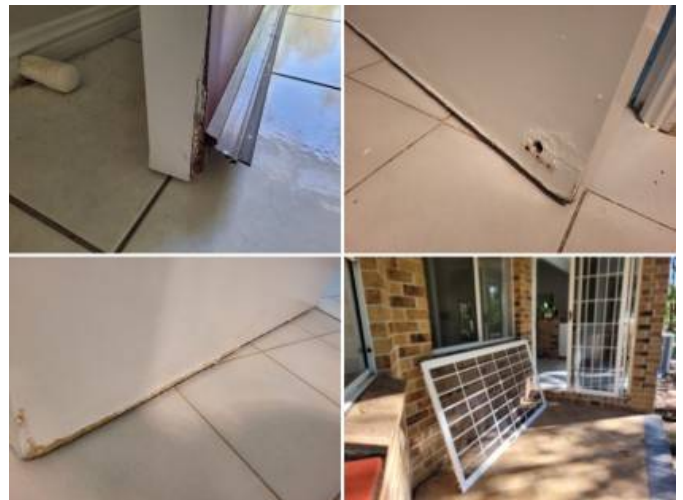
Base of some doors show signs of swelling and require repair / repainting.

Holes in gauze to some screen doors may require repair / patching / replacement.

Screen door shows signs of rust and requires repair / painting with Killrust or better.

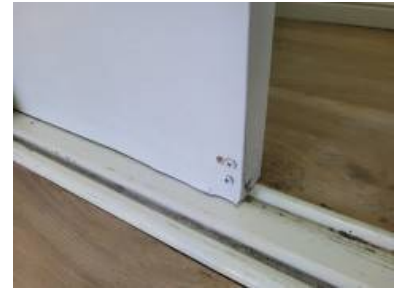
Minor damage to robe door requires repair .

Some door handles / latches & catches require installation / refitting.

Some doors show signs of binding and require repair / adjustment.

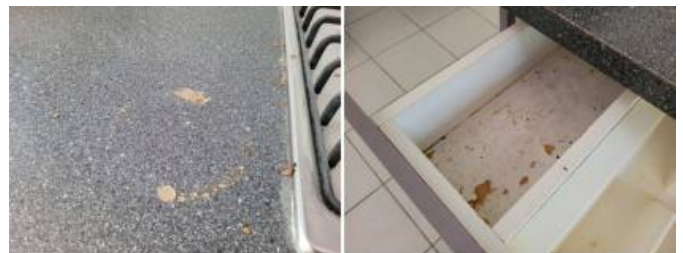
Surface wear, small chips & scratches to some laminate.

Surface wear to some laminate bench tops & joins.

Minor damage to bench top.

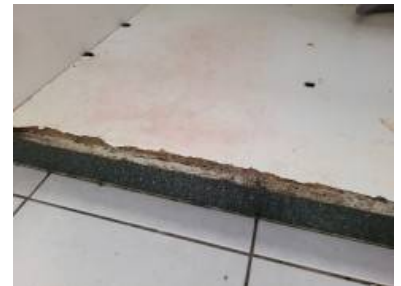
Signs of past water penetration swelling to Shelf under sink.

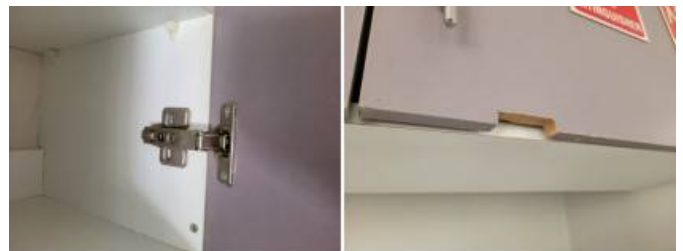
Door above the fridge space shows signs of damage / has a cut out.

Some loose hinges require repair / refixing.

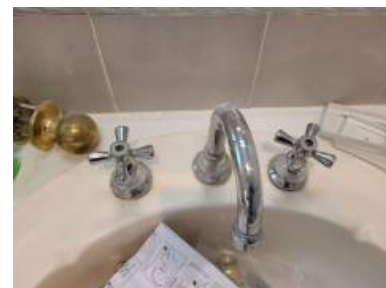
Hot and cold indicator buttons are missing to some taps.

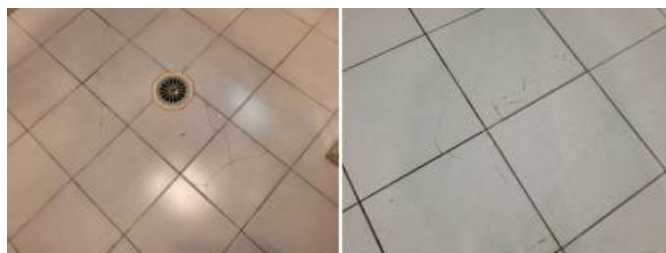
Drummy floor tiles to some areas. Floor tiles become drummy due to the loss of adhesion to the underside of the tiles and require refixing.

Various cracked / chipped / damaged floor tile.

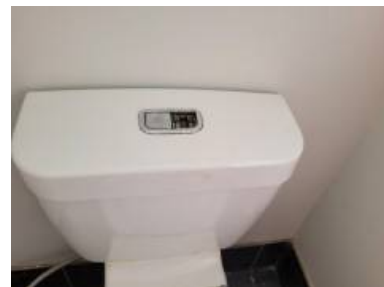
Toilet pan base to the Ensuite is loose and requires refixing.

Toilet roll holder to the Ensuite requires replacing

Cistern flush button requires repair / replacing.

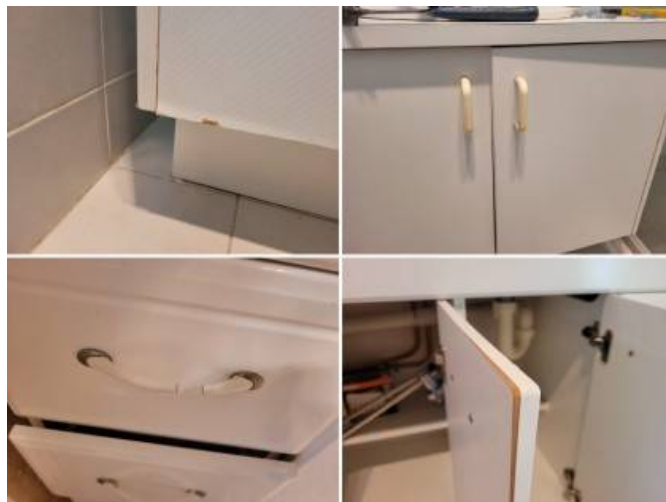
Surface wear, small chips & scratches to some laminate to Bathroom & WC vanities.

Damaged handles to the Ensuite vanity cabinet requires replacing.

Some laminate shows signs of lifting to the Ensuite vanities.

Some hinges show signs of corrosion.

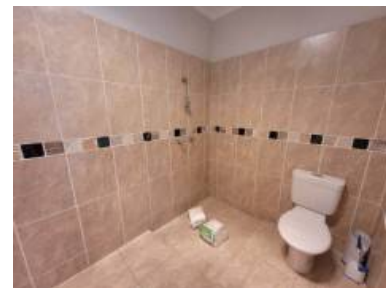
No screen or shower curtain present to the Ensuite, installation may be required.

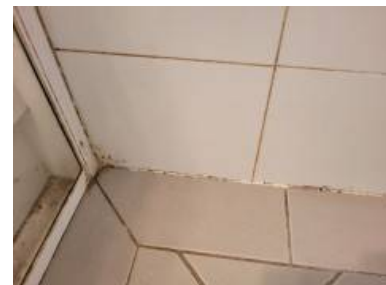
Floor tile grout shows signs of mould & require cleaning / regrouting

Junction of the floor / wall tiles shows signs of mould & require resealing with silicone.

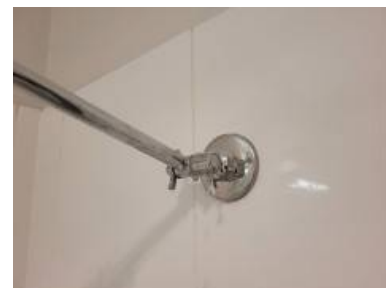
Shower head to the Bathroom is leaking & requires repair.

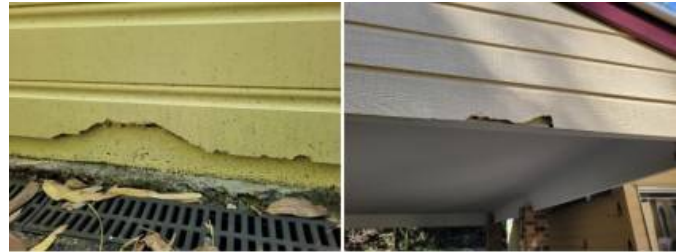
Some hardiplank or similar sheeting shows signs of minor damaged and requires repair / patching.

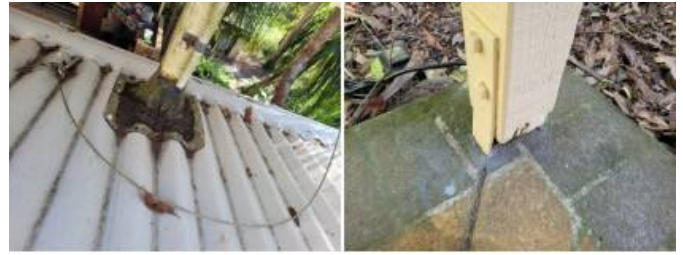
Some verandah / patio post bases show evidence of decay and require repair / sealing.

Patio restraint requires repair reinstating.

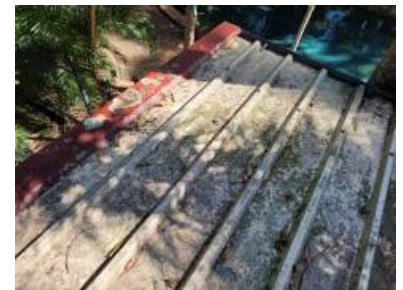
Signs of moss growth to the Carport & Patio roof sheets requires cleaning.

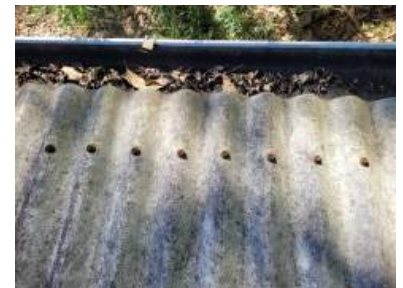
Some roofing screws to the Carport show signs of rust and require replacement. Failure to do so may allow the rusted screws to cause rust to the roof sheeting.

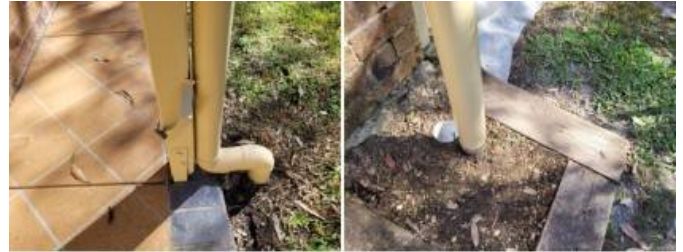
Redundant downpipe brackets require removal

Downpipe brackets require to some downpipes.

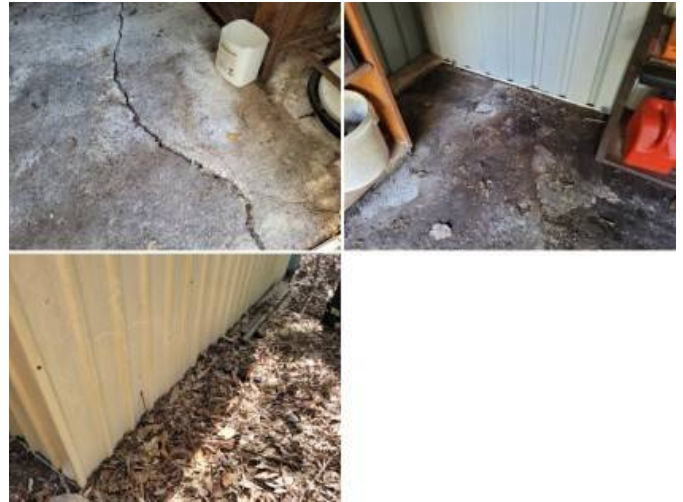
Expose slab edges and bases of wall sheeting for the prevention of rust

Signs of past water penetration within the garden shed.

Some cracks to concrete slab.

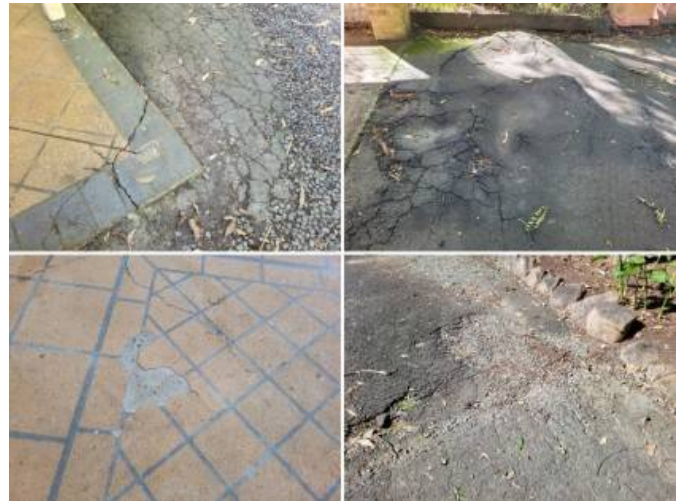
Some cracks to concrete slabs.

Some bitumen shows signs of cracking / breaking up & may require resurfacing

Tree roots have caused significant damage to the bitumen adjacent the Carport

Applied paint finish to the Patio shows signs of wear.

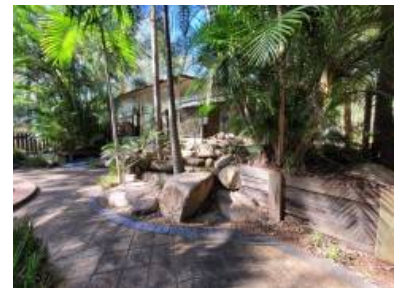
The timber retaining wall shows signs of movement, weather damage and decay and will require rectification work / replacement at some stage in the future as timbers decay further. I strongly recommend that an appropriately qualified tradesman be engaged for further investigation and to quote the cost of rectification (if required) prior to making a purchase decision.

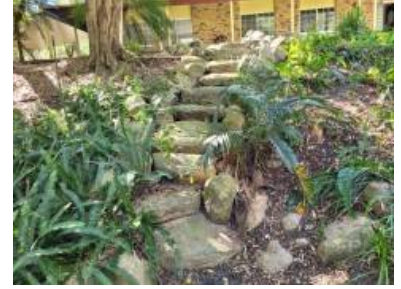
The stair treads & risers do not comply with current BCA standards however, they may comply with the date of construction. Although this report does not generally comment on items of compliance, this issue may become a safety issue / fall hazard and therefore was included in this report. We recommend you further investigate this matter and upgrade if / where necessary.

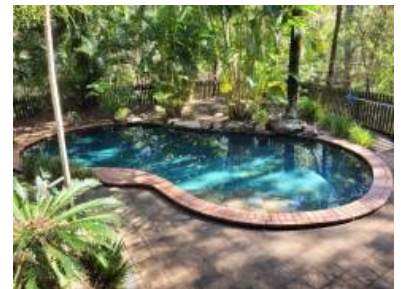
The timber fencing to the pool shows signs of weather damage and will require rectification work / replacement at some stage in the future as timbers decay further.

Some timber fence post shows signs weather damage / decay and termite damage & will require rectification work / replacement at some stage in the future as timbers decay further.

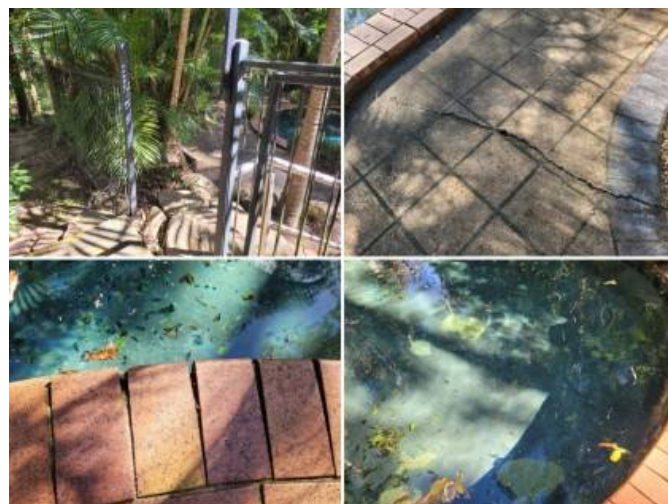
The pool lining shows signs of deterioration / peeling & requires repair / recoating.

Some cracks to concrete slabs.

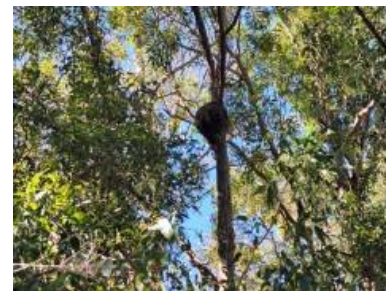
Arboreal termite nest present in tree at rear.

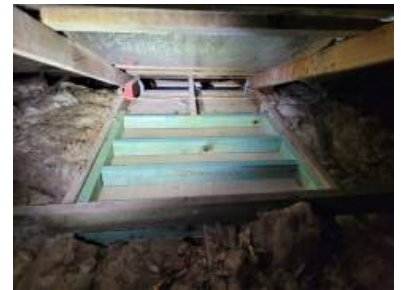
Ceiling joists.

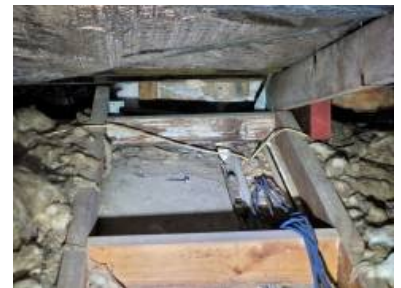
We found evidence of past water penetration to the roof area.

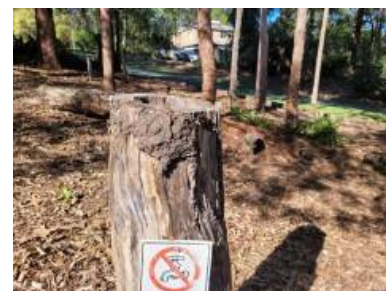
Tree stump to the front of the property.

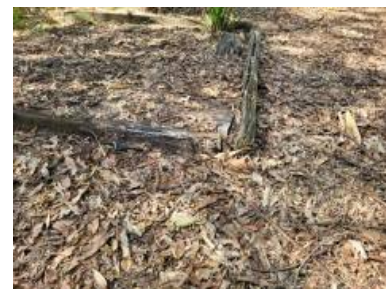
Various Garden sleepers.

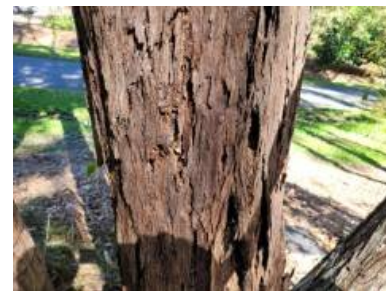
Some tree stumps around the property.

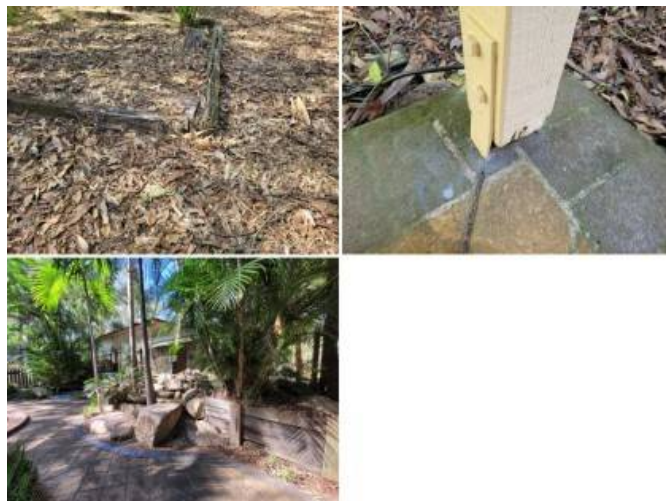
Some external garden timbers, retaining wall sleepers, base of some verandah posts.

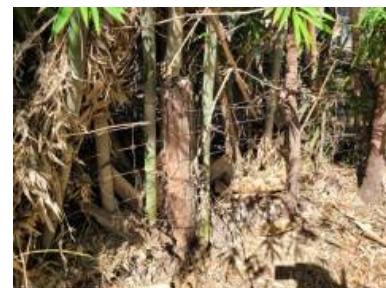
Affected timbers were mainly but not limited to the following fences - Various fence posts.

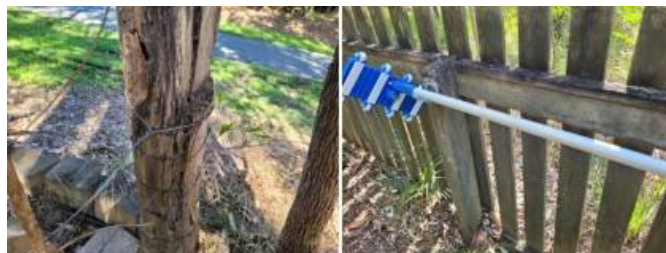
Various fencing around the property.

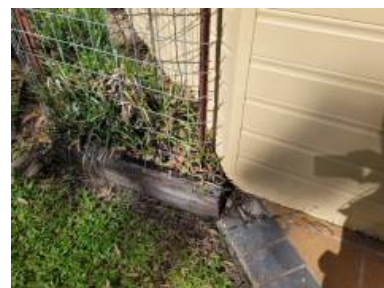
IMMEDIATE ATTENTION REQUIRED - Where the external concrete slab edge has been concealed by paths, patios, pavers, soil, lawn, gardens, etc it is possible for termites to gain concealed entry into a building. The slab edge has been partially or completely concealed. Termites can gain concealed entry into the external walls (this may already be the case) and may then not be detected until they cause damage either to the inside of the building or the roof void timbers. You should obtain written details of any termite barrier that may have been installed to overcome the concealing of the slab edge. If no such barrier has been installed or the expected life of the barrier has passed or is about to pass then you should arrange for the slab edge to be exposed or a termite barrier to be installed.
