Routine Inspection Owner Notification Report

Property/Inspection ID: **PR1112174 / IS1729297**
 Current Rent: **\$280 / Week**
 Lease Start/End Dates: **13/01/2017 / 12/01/2018**

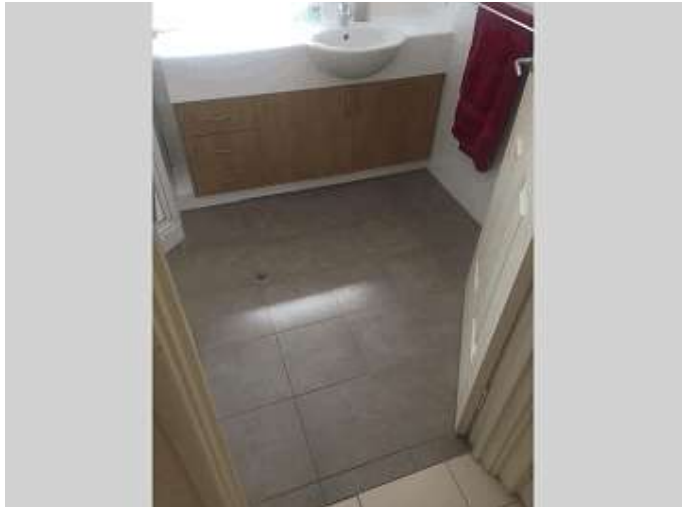
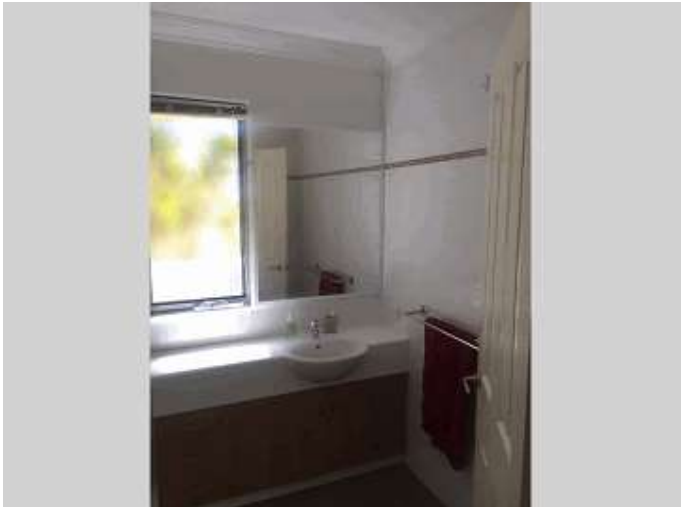
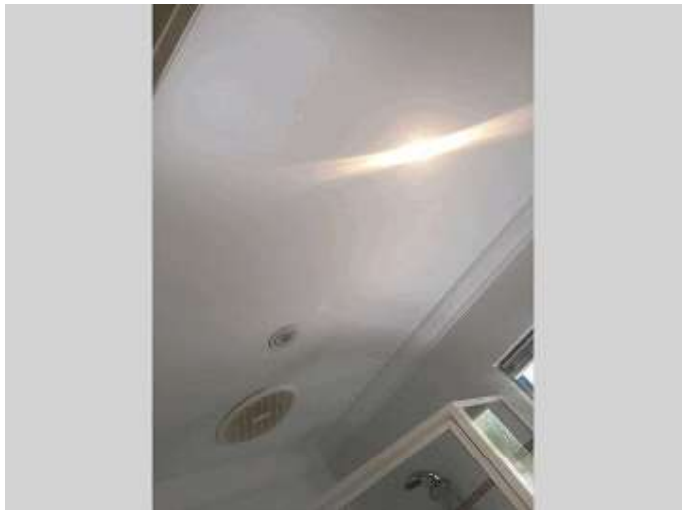
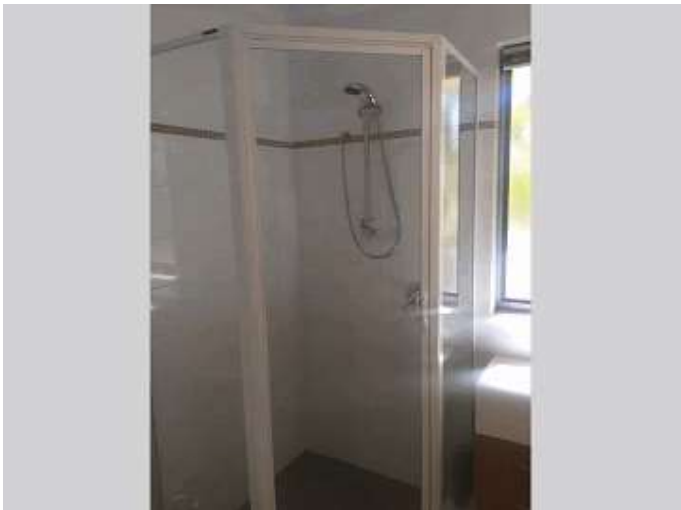
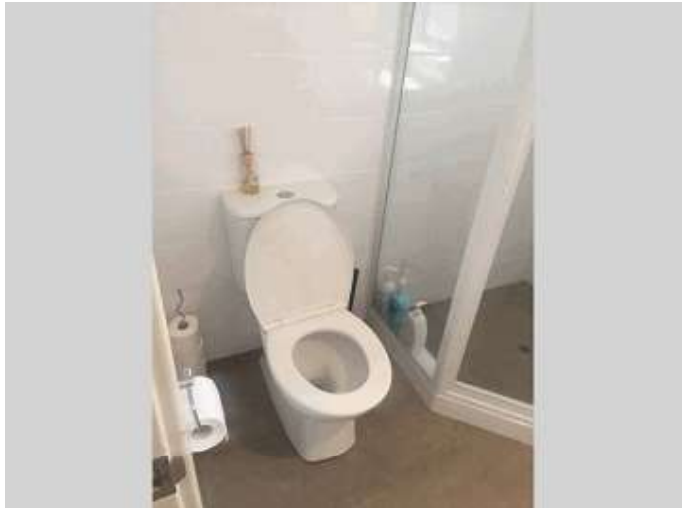
Bathroom (1)	√			Bathroom is clean and maintained. Shower screen, floor and wall tiles, basin and exhaust all clean and intact. Toilet bowl and lid clean. 1x bulb blown. Lock mechanism has been repaired. Plumbing appears in good working order
Exterior	√			Front of property present well, plants healthy. Lawn is green and mown, appears really well presented. Patio area is clean and tidy with an outdoor setting present. Pavers have been swept and appear undamaged.
General	√			All items appear in good working order

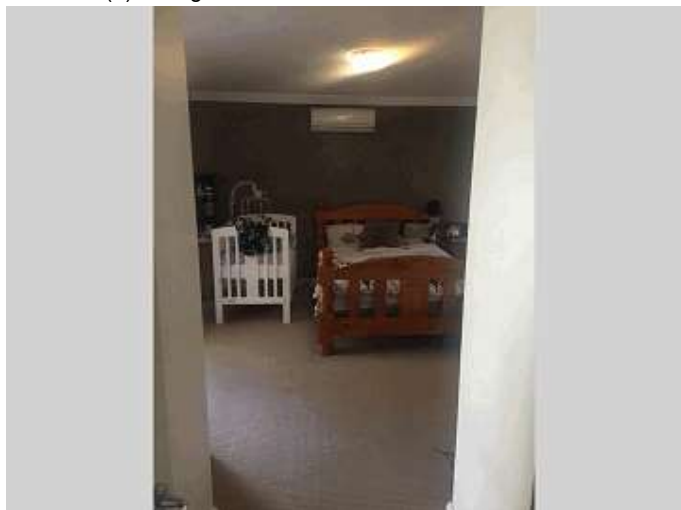
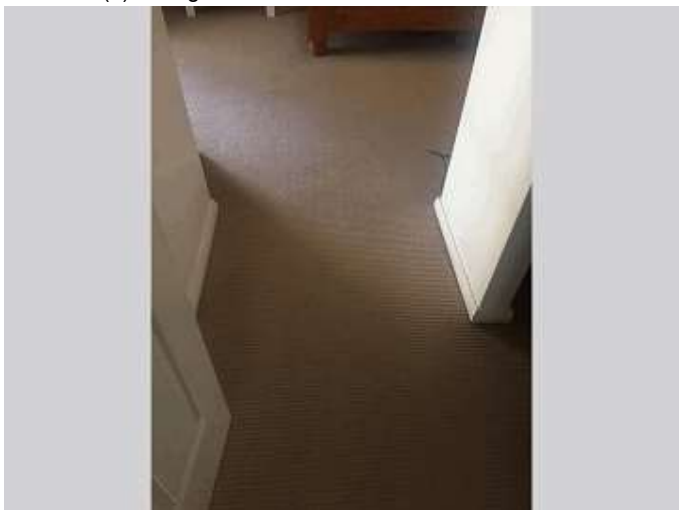
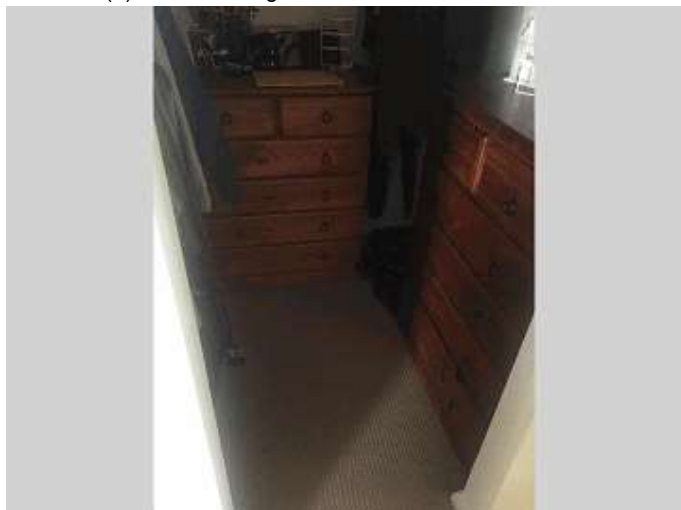
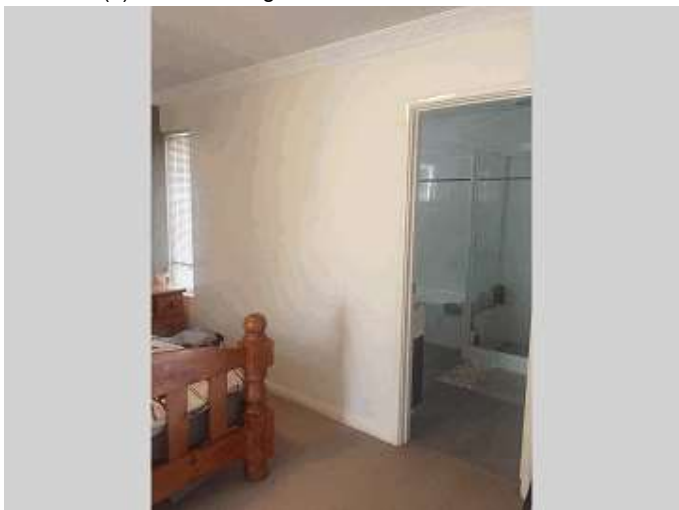
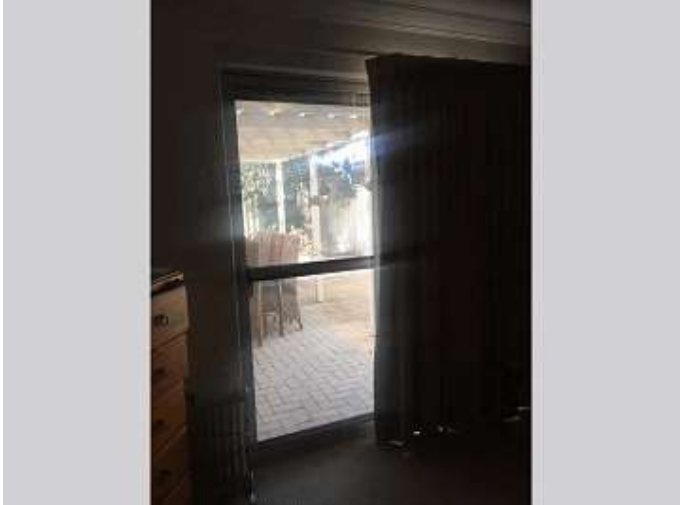
Bedroom (2) master	√			Room clean and tidy, floor appears vacuumed, blind and curtains intact, lighting is working, cover clean. Air con unit clean but no tested. Glass sliding door secure with no issues. Area appears well maintained.
Ensuite	√			Shower screen, floor and wall tiles, basins and bath all clean and intact with no appearance of staining, leaks or damages. Toilet is clean and appears to be working well. Towel rail is attached. Soap dish was snapped but tenants are due to repair
Bedroom (3)	√			Room clean and tidy, floor tidy with some baby items present, curtains intact and lighting is working, cover clean. Used as a play area. Carpets appear clean and undamaged.
Garage/Carport	√			Area tidy, oil staining and tyre marks to flooring. Fluro in place, covers present. garage door appears in good working order and undamaged. Pedestrian door has paint peeling on frame and is slightly stiff to open

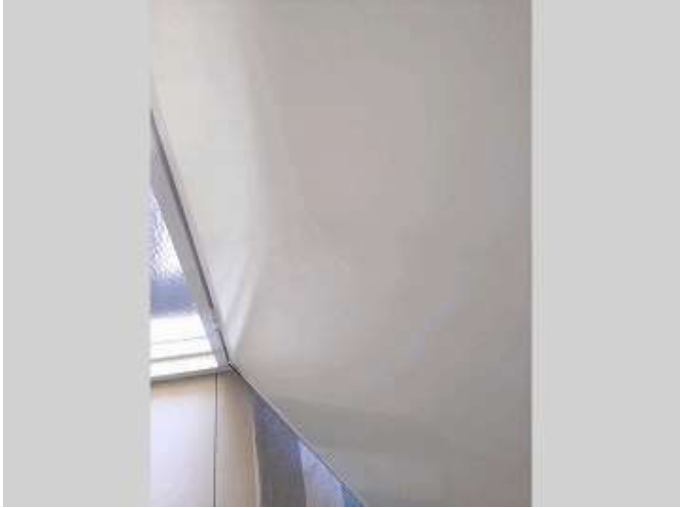
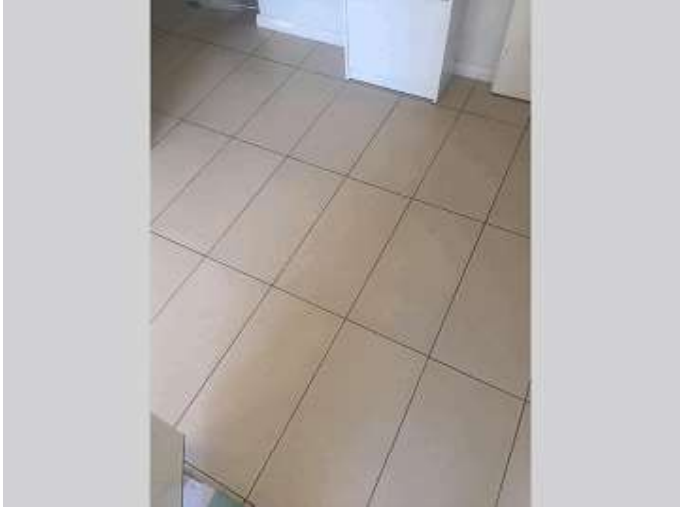
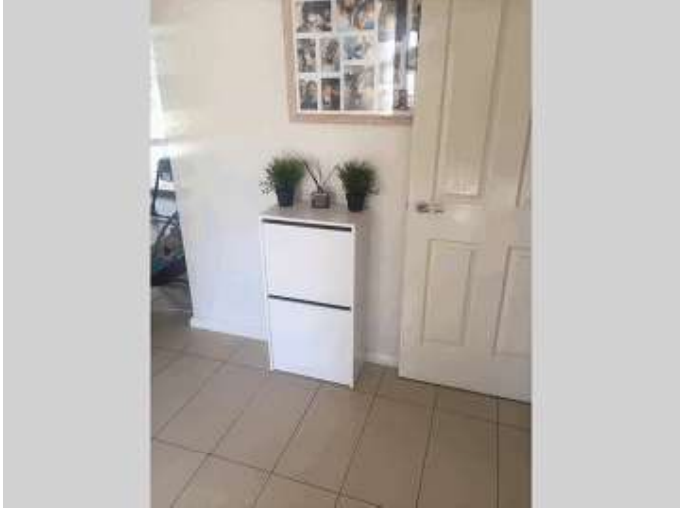
Room	Good	Fair	Poor	Comment
Entrance/Hall	√			Entrance clean and tidy, tiles clean and mat also clean and tidy. Locks are intact and working well. Scratch mark appears to have been cleaned, a few light smudge marks remain. Area is well presented.
Lounge Room	√			Room is tidy, floors are clean, walls intact. Lighting is working, curtains and blinds both in good condition. Air con unit clean but not tested. Glass sliding doors secure and intact with no issues. Area appears well maintained.
Kitchen	√			Kitchen is maintained. Floor, bench top, wall tiles, cooktop, over and sink space all clean With no staining/damages. Lighting works. Sink mixer is slightly loose. Oven light has stopped working. Stove takes a while to light
Laundry	√			Laundry clean and tidy. Trough is clean, tap ware intact. Plumbing appears in good working order. lighting is working and the floor is clean.
Bedroom (1)	√			Room clean and tidy, floor appears vacuumed, blinds intact and lighting is working, cover clean. Area appears well maintained.

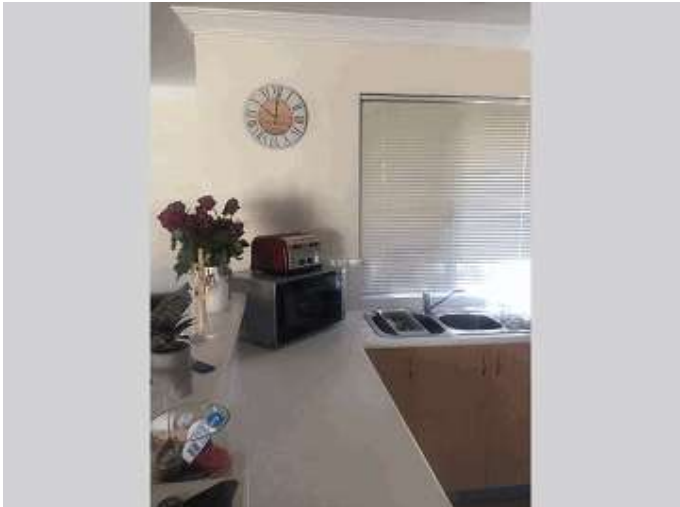
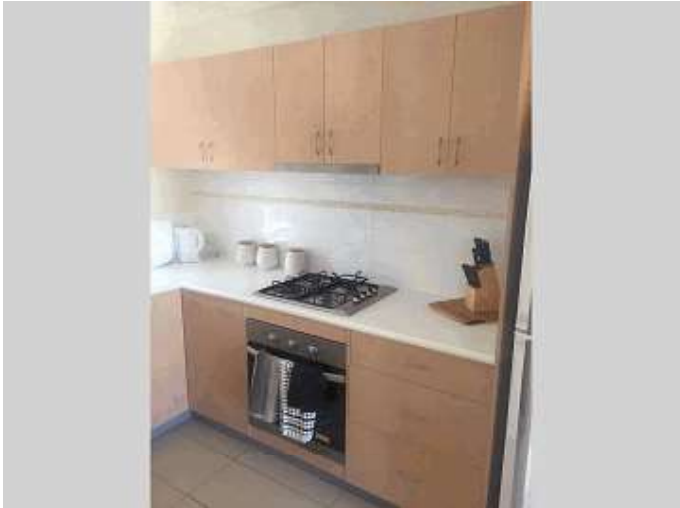
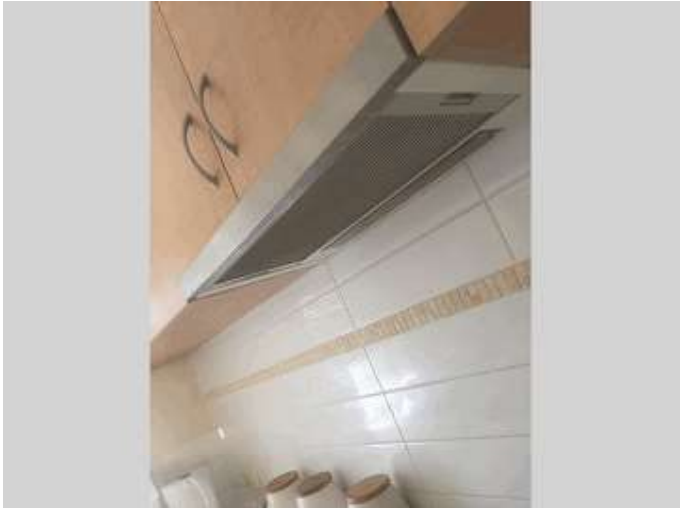
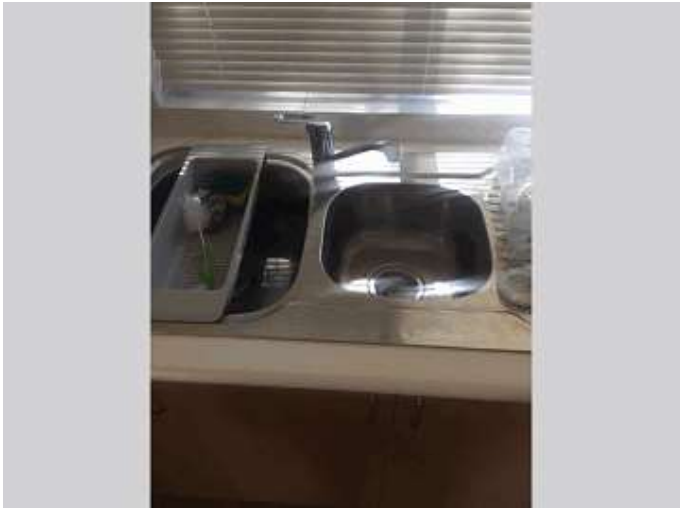
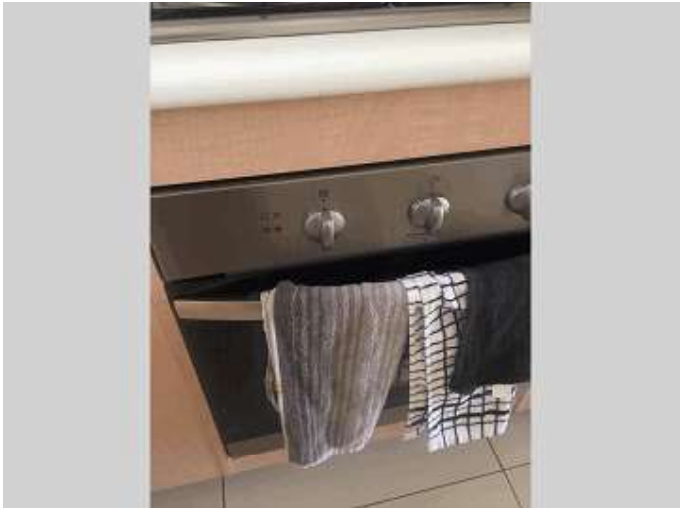
Repairs Required Now	<i>Oven light has stopped working and stovetop takes a while to light, fills house up with a gas aroma.</i>
Rent Appraisal	<i>Nil</i>
Future Work To Consider	<i>Nil</i>
Other Comments	<i>Nil</i>

Date Raised	Work Order ID	Priority	Work Type	Status	Supplier Name
28/06/2017	WO2016657	Medium	Standard Maintenance	Work Order Issued	The Property Repairman
<i>rain damage to roof area</i>					
11/09/2017	WO2046499	High	Standard Maintenance	Work Order Issued	Plumber, Plumbing & Gas Solutions - House and C
<i>Gas stove top difficult to light up.</i>
