BUILDING & PEST INSPECTIONS

9 Spotted Gum Lane, Cashmere

BPI - INSPECTION REPORT

9 Spotted Gum Lane, Cashmere.

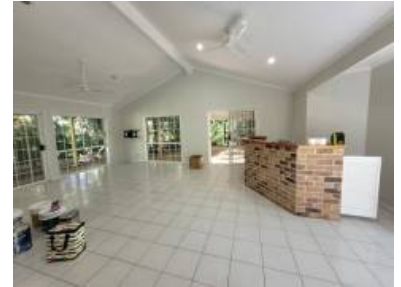
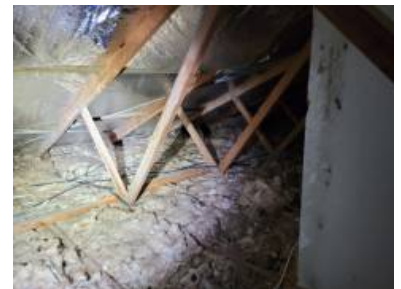
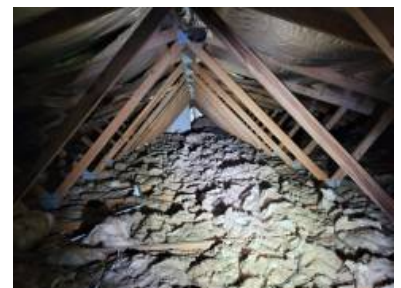
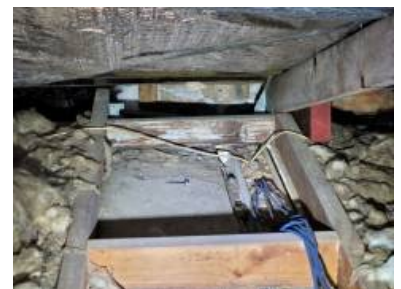
Wool type insulation is present in the roof cavity.

Foil Blanket Insulation (fibreglass batts covered in foil) is present in the roof cavity to the underside of the roof sheeting.

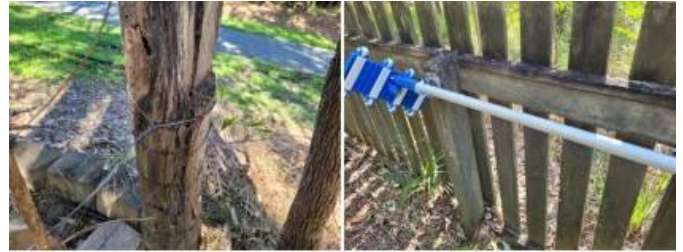
The timber fencing to the pool shows signs of weather damage and will require rectification work / replacement at some stage in the future as timbers decay further.

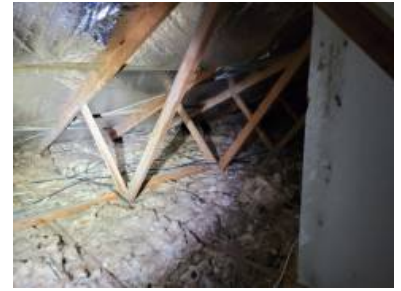
Insulation is present in the roof cavity. This restricted inspection to some roofing & ceiling members and wall top plates. Removal of insulation is not within the scope of a standard visual timber pest inspection report.

Foil Blanket Insulation (fibreglass batts covered in foil) is present in the roof cavity. This restricted inspection to some roofing members. Removal of the Foil Blanket is not within the scope of a scope of a standard visual timber pest inspection report.

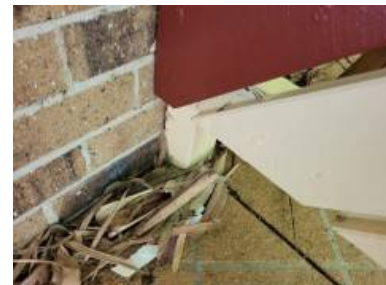
- It is recommended that all untreated timbers in contact with the soil be removed or replaced with a treated timber or non timber alternative or treated with termiticide as they may be concealing termite activity and are highly attractive as a food source. It is not possible to fully inspect these timbers and they may be concealing termite activity and/or damage. This will

only be discovered when the timber is removed.

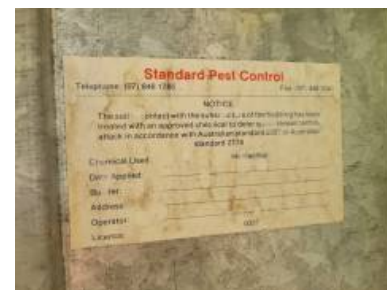
PHYSICAL EVIDENCE:

Refer to Label in Meter box.
